## Application of Infrared Thermography to investigate the 14<sup>th</sup> century wall paintings at Germolles

**Reference:** Short Term Scientific Mission, COST TD1201

**Reference code:** COST-STSM-TD1201-32432

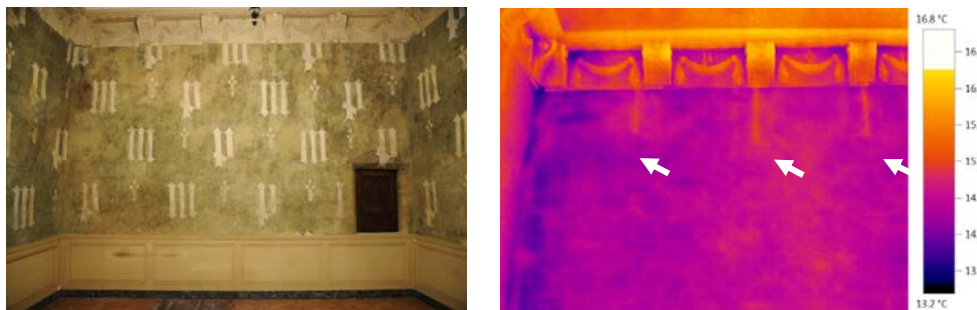
Examination started on the western wall where more detachments were detected. The IRT pictures show the masonry texture and some constructive details such as the wooden slats (white arrows) in the upper parts of the walls.

Preliminary observation of the walls with passive IR thermography carried out on upper portion of dn west wall

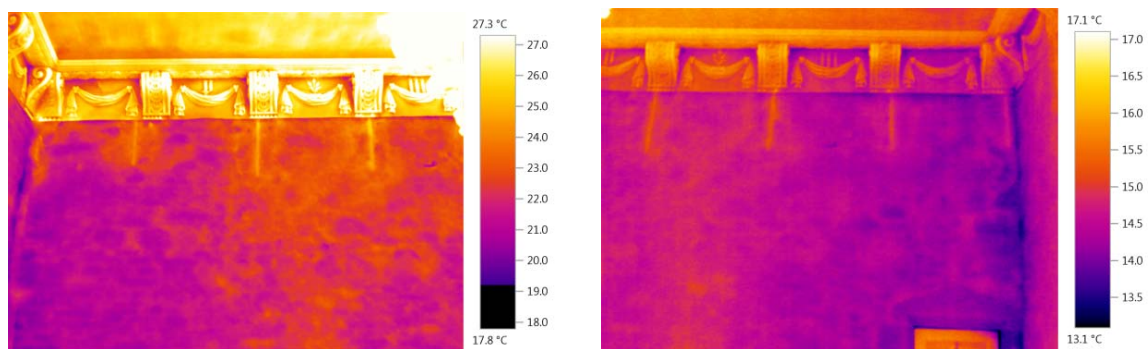
Observation of the walls with active IR thermography of the south corner of the upper portions of dn west wall. The thermal images are more complete and show texture details.

IR thermography used in passive mode gave some preliminary information on masonry texture and construction details of the walls, but active IRT gives more clear results. Dynamic IRT enabled us to appreciate the level of detachment of the decorative plasters from the walls (the mainly west and north walls of Countess of Nevers' dressing-room) which were concentrated on the upper part of the walls.

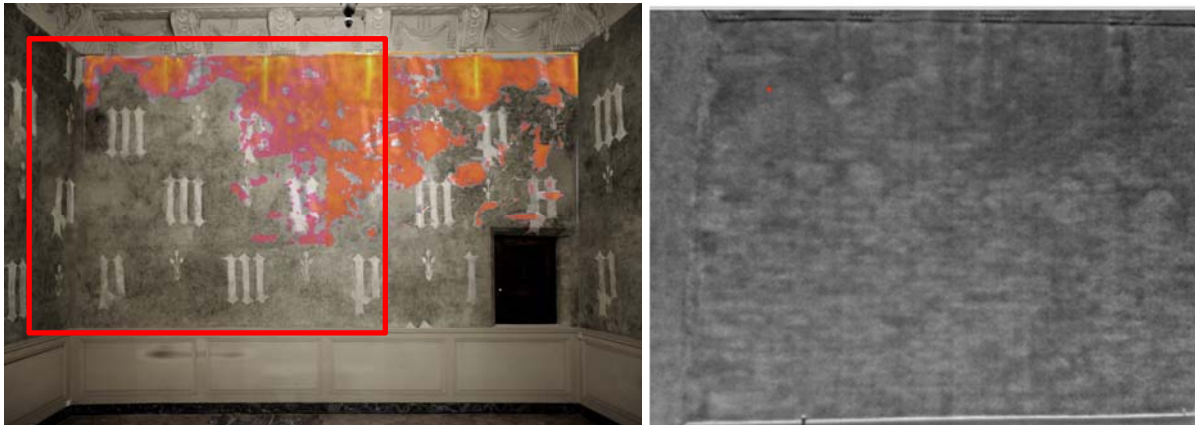
To obtain more information on the wall structure, after heating, IRT images were recorded at regular time intervals (every 20 seconds) during the cooling phase. In post processing the cooling process of each pixel is analysed by FFT to obtain details not evident with the active IRT. Figures show that it is possible to recognize the brick texture in non-detached areas.

Fourier analysis applied to dynamic IRT on the west wall of dn (b) compared to detached zone identified on dn\_w. (a).

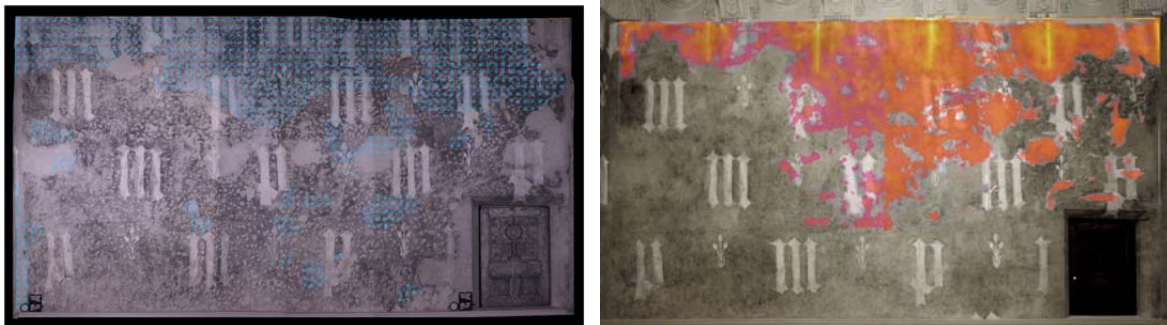
Dynamic IRT data analysed with FFT showed that internal walls in the château are made of bricks while external walls contain both stones and bricks. The walls were systematically assessed to detect delamination with the knocking method, the results were graphically mapped by Nutsa Papiashvili to show in Figure where detachment (identified by an hollow low frequency sound) was perceived. Mapping was done over an IR-reflected image of the wall (obtained with technical photography in a previous STSM) to allow to assess if the adhesion problems are somehow associated with reconstructed areas. Tactile assessment (knocking test) fully confirmed the results obtained by IRT, but no relationship was found with reconstructed areas.

Comparison between the graphical representation of the mapping result obtained by knocking method (a) and detached zones identified by IRT on the west wall of dn (b). There is a good correspondence with the results of the manual knocking tests, especially in the upper part.
